ISSN: 0973-4929, Vol. 20, No. (1) 2025, Pg. 443-462

The Plight of Wetlands in India: A case Study of Ansupa Lake in Cuttack, Orissa

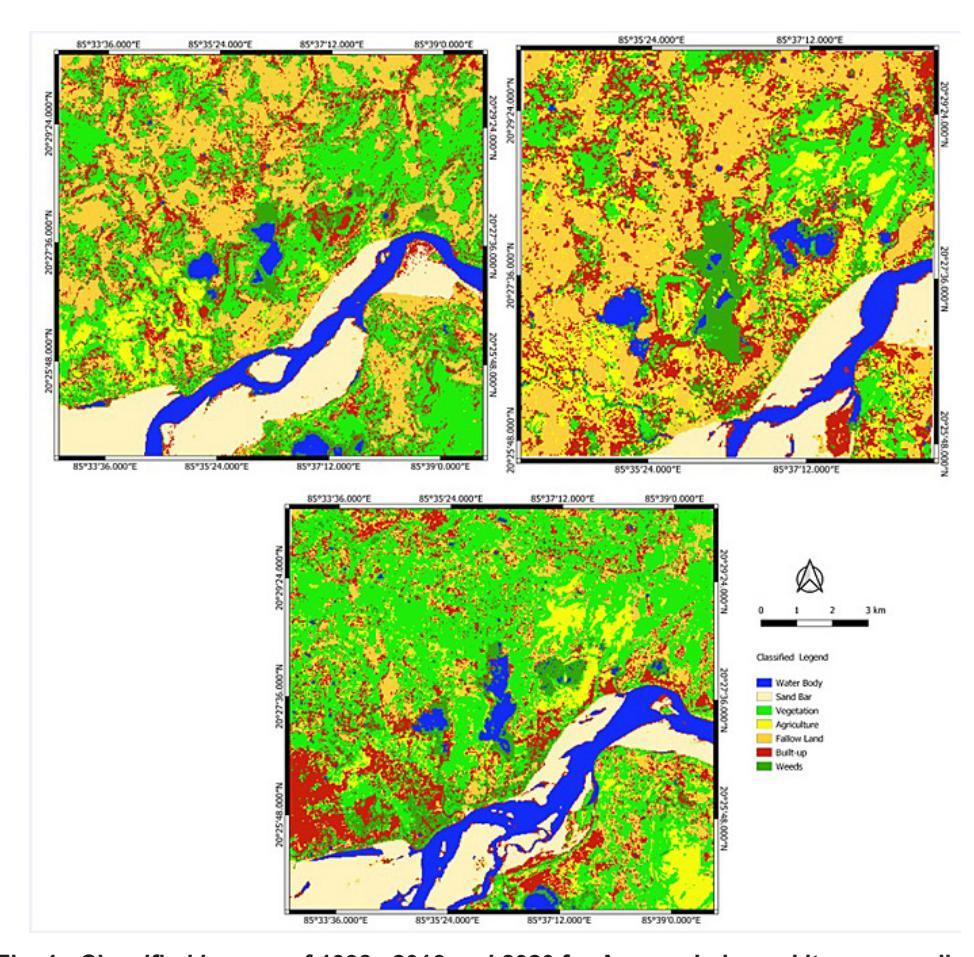
Fig. 1 : Classified images of 1998, 2016 and 2020 for Ansupa Lake and its surroundings (clockwise from left); Source: Landsat 5 TM and Landsat 8 OLI/TIRS and Authors' elaboration.

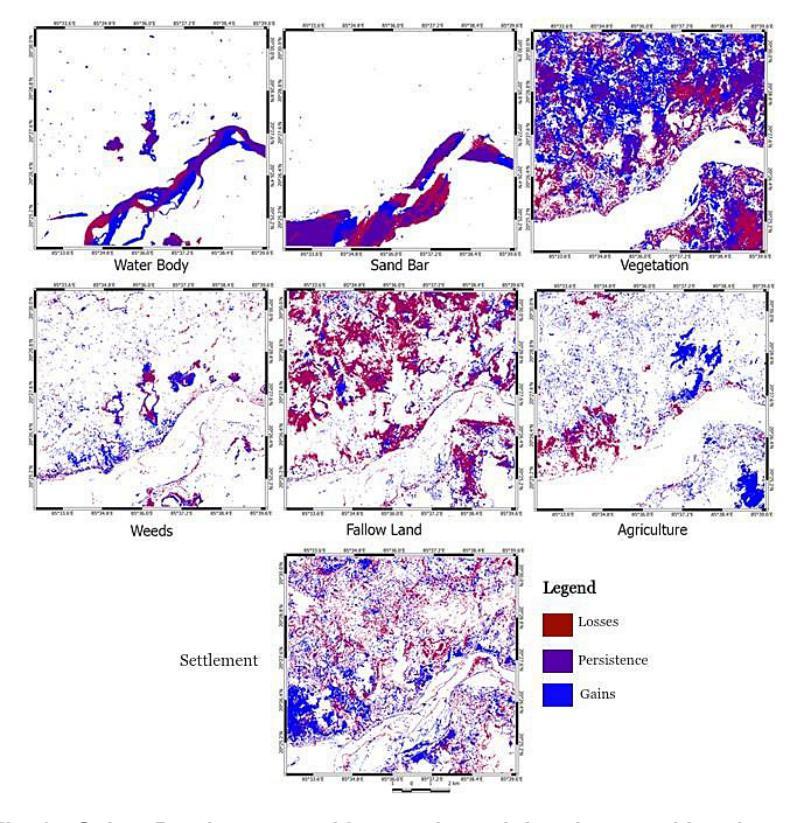
Fig. 2 : Gains, Persistence and Losses in each Land use and Land cover Category (1998-2020); Source: Landsat 5 TM and Landsat 8 OLI/TIRS

According to figure 2, the shades of red, purple and blue have been used to depict losses, persistence and gains in areas, respectively, within the LULC categories from 1998 to 2020. Considering the water bodies, it is evident that the Mahanadi River has shifted from its original course and lost a few stretches. Persistence of the main river course still dominates while a few new stretches have been gained as a result of government initiatives. The same activities have allowed Ansupa Lake to witness persistence of its waterspace which existed during 1998, while gains have happened in its northern and southern sections, although a few losses are seen towards its western side. Sand bars have suffered a loss since its 1998 levels due to the changes in the river course. Some sand bar portions still persist whereas negligible gains have happened here. Vegetation on the other hand, has seen major gains while some vegetal spaces still persist towards the eastern, extreme west and southern sides. Losses in this category are seen scattered around the region mainly due to clearance of land for settlement or agriculture. In the context of weeds, it is evident that the source is the Mahanadi River and its offshoots, from where the weeds stagnated within the lakes. Weeds along the river's southern banks have apparently disappeared while along the western offshoot there has been a gain as it is gradually losing its vitality, owing to river course changes. Ansupa Lake has witnessed loss in weeds in the northern and southern sections while gains and persistence still do exist for its neighbouring lakes. Fallow lands have lost more areas than it has gained, within the given time period. Minor persistence still exists and is scattered in the western and southern parts of the region. In the context of the agricultural regions, gains apparently dominate the region. There has been both a loss and a minor persistence in this category, as is evident towards the west; which is explained by the gains in the settlements which have mostly replaced the agricultural fields there. Gains in the rural residences are seen in compact forms, mainly along the river and the North western part of the region. Settlement areas have seen a trend of gain in areas towards the west than the eastern halves. Persisting settlements exist in the extreme northern and south-eastern side, while losses are seen in the central, north and eastern sides. Such diverse changes around the Ansupa Lake, ranging from losses to gains have greatly impacted it. Even the river course also had a significant impact on the lake. Sometimes the lake areas have been occupied by weeds, sometimes by agriculture or even by the local vegetation. So to find out the type of transition the lake areas have undergone since 1998-2020, a transition map of waterbodies to all other categories has been conducted as can be seen in the following figure (Figure 3 below).

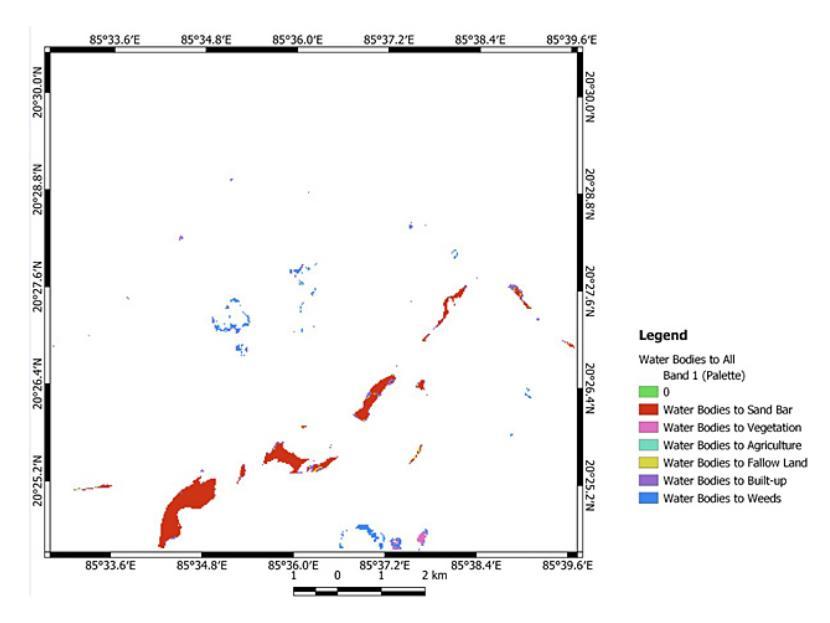
Fig. 3 : Transformation of water bodies to respective LULC categories, Source: Landsat 5 and 8 imageries of 1998 and 2020, respectively, and Authors' elaboration.

From the given transitional patterns, it is evident that portions of the river have changed into sand bars primarily, followed by some regions morphing into weed occupied regions, vegetal space and minorly into settlements or fallow lands. On the other hand, in case of the enclosed water bodies, the Ansupa Lake has seen a major conversion to weed areas, native vegetal areas, settlement spaces and agricultural regions mainly. Some of its neighbours have also experienced a similar pattern of change from waterspace to weeds, settlements and agriculture. As a result of such transitions, Ansupa is always vulnerable to a decline in water quality and quantity like its neighbours, which in turn affect not only the vitality of the fishes but also the avian migratory species who depend on them for food. Moreover, this lake is used for commercial fishing as well as recreational activities like boating. This not only affects the lake's physico-chemical properties but also allows more reclamation of the surroundings of the water bodies to fulfil human needs. Thus, there exists a need to assess the trend of transformation potentials of water bodies to other LULC categories, which has been conducted using the cubic trend analysis and has been shown in the following figure (Figure 4).

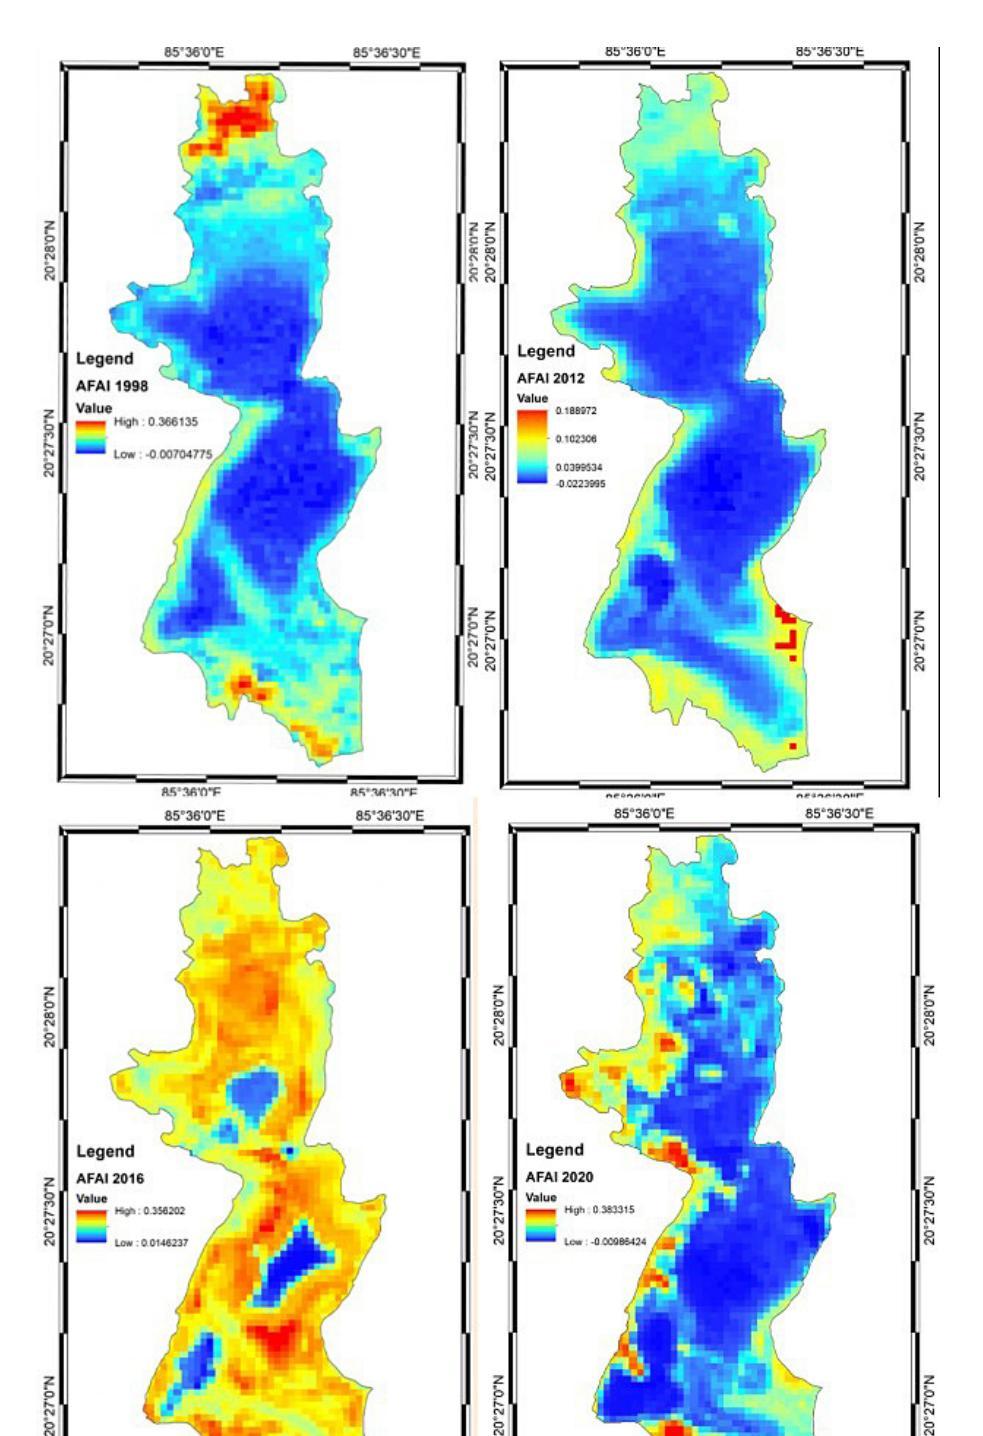
Fig. 5: Adjusted Floating Algae Index (AFAI) for Ansupa Lake, Orissa for the years 1998, 2012, 2016 and 2020; Source: Landsat 5 and 8 imageries and Authors' elaboration.

The Adjusted Floating Algae Index (AFAI) in figure 6 explains that in 1998, the floating algal and weed content was much higher in the extreme northern and southern part of the lake. This gradually reduced towards the centre where clear water expanse is noticed, marked in blue. This algae/weed borders the lake even on the left and right sides thereby reducing clear water extents. This changes in 2012 where high density weed-algal cover is less intensely found than the previous image. Water areas have increased suggesting partial cleaning activities towards the southern sides mainly. Here greater weed-algal density is found towards the south-eastern corner (on the lower right) suggesting piling of vegetal mass along the banks of the lake. In 2016, there was a sudden weed invasion where floating algae and weed cover strangely increased by volumes. As is evident only around 10-15% of the water bodies remained clear while floating masses dominated the rest of the lake. This may be attributed to the increase in agricultural dynamicity of lake's surroundings and eutrophication by agricultural effluents. Following this situation a complete lake clean-up was attempted by the government and the locals so as to rejuvenate the lake, due to which in 2020 water area of the Ansupa Lake has increased manifold. Inspite of this it can be clearly seen that the left banks of Ansupa still has a dense cover of floating algal and weed content, suggesting the fact that a thorough clean-up was not possible considering the rate of proliferation of weeds and algal masses.

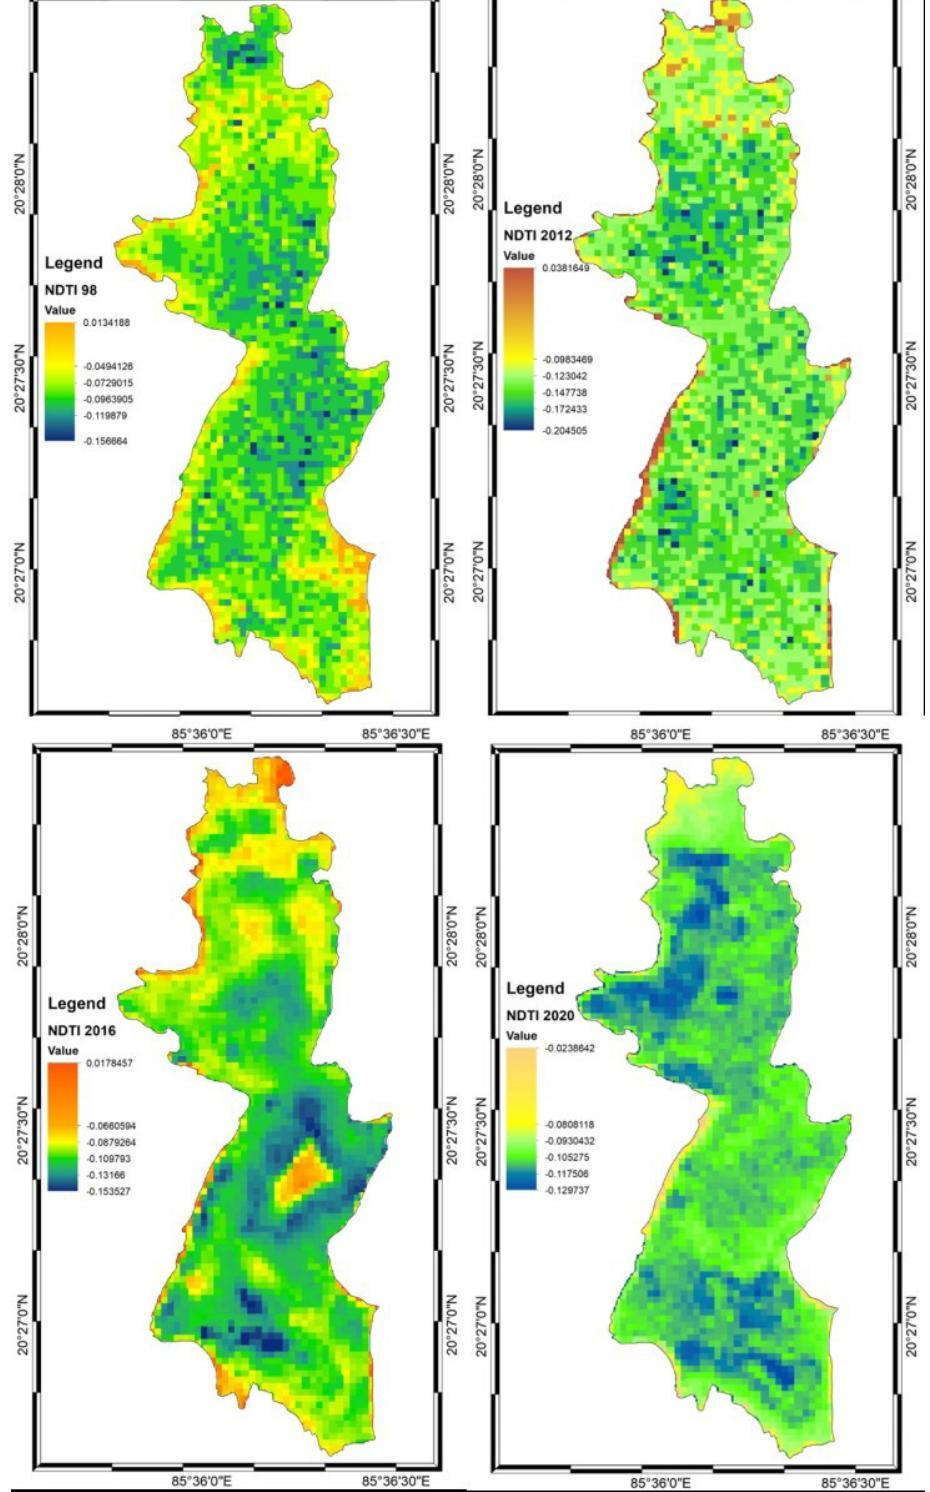
Fig. 6: Normalised Difference Turbidity Index (NDTI) for Ansupa Lake, Orissa for the years 1998, 2012, 2016 and 2020; Source: Landsat 5 and 8 imageries and Authors' elaboration.

In case of the Normalised Difference Turbidity Index (NDTI) which has been shown with the help of Figure 6, the picture turns out to be completely different.

In 1998, there exists a direct relationship between waters replete in weeds and algae and turbid water regions. Consequently, Ansupa's northern portions, its left bank and its south-eastern periphery have highly turbid waters. Contrary to this aspect, the central most part of the lake which was free of any floating masses, was comparatively more turbid than expected. This may be due to the effluent and silt being discharged in the lake which even renders unrestricted water areas turbid. Following this in 2012, mixed turbid conditions are noticed although the intensity of turbidity along the banks have increased than before. Very few clear patches

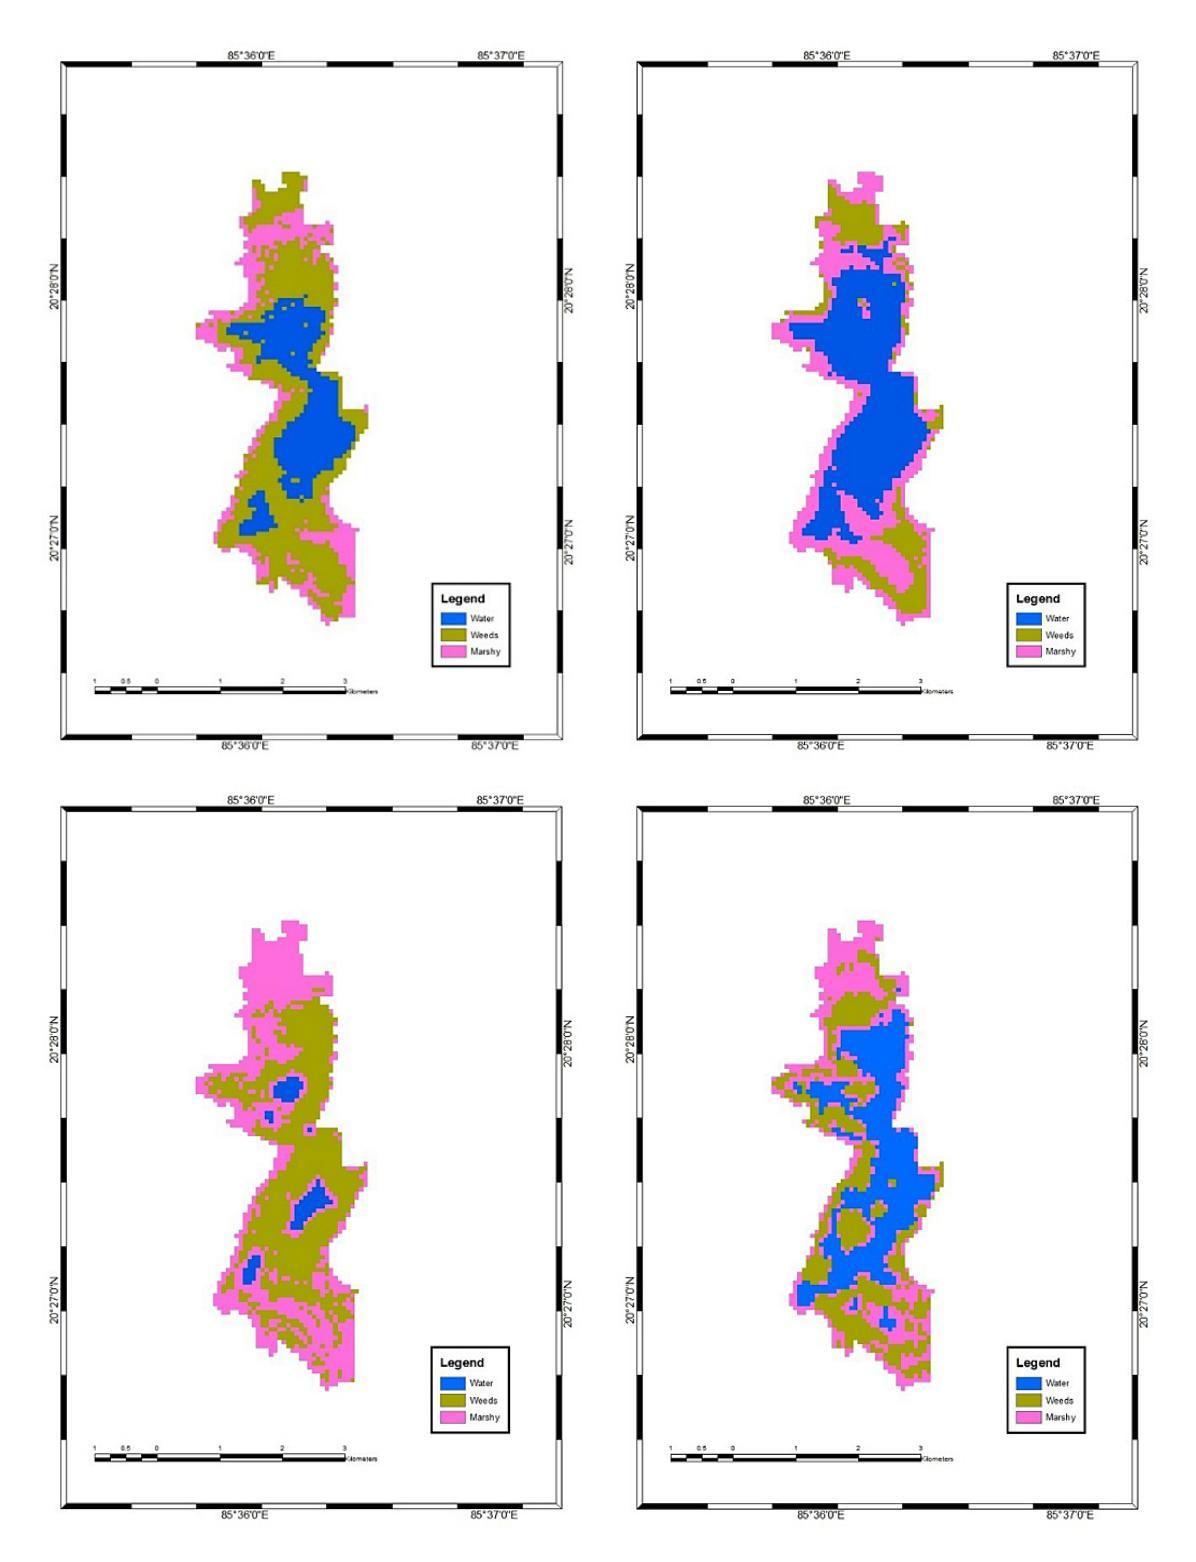
Fig. 7: Different status of the lake from 1998, 2012, 2016 and 2020; Source: Landsat 5 and 8 imageries of 1998 and 2020 and Authors' elaboration.

Additionally, to understand the percentage of change within the Ansupa lake, Landsat 5 and 8 images for the years 1998, 2012, 2016 and 2020, were used to classify it into 3 tiers - the weeds, marshes and water body clear of any obstruction. The resultant images, as seen in Figure 8, have depicted that marshes and weeds used to occupy a major part of the lake in the first chosen year (17.35% weeds, 45.30% water and 37.35% by marshes). By 2012, clearance of weeds helped the lake waters to occupy a larger area and provide better ecosystem services to the inhabitants. In this year, 20.63% of area was found to be occupied by weeds, 26.59% by water bodies while 22.19% was occupied by marsh. But sediment addition, algal bloom due to agricultural nutrients, increased wastewater flow and low fresh water supply from the Mahanadi, coupled with people's neglect led to the 'almost' extinction of the wetland by 2016. Here 48.02% of the area was under weeds, 4.51% was water and 47.46% were marshes.

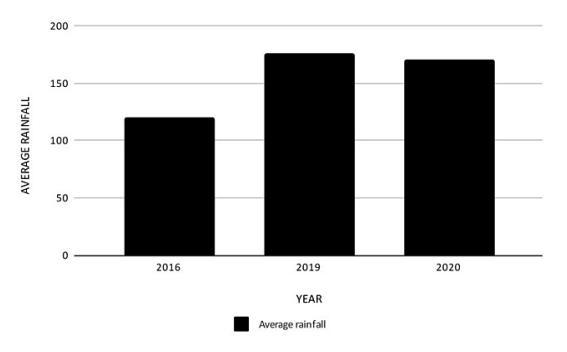
Fig. 9: Average annual rainfall (in mm) of Banki Subdivision, Cuttack(Orissa) for the years 2016, 2019 and 2020; Source: India Water Resources Information System(IWRS)

In the context of rainfall, the data portrays that the region has recorded a considerable increase in rainfall since the year 2016 (Figure 9), i.e., from 120 mm to 170mm. Yet the groundwater has not simultaneously increased as can be seen in Figure 10. The Piezometric level shows that from 2010 the groundwater level was around 3.3 mbgl, and has dropped slightly but steadily till 2012 by the next year to about 4.95 mbgl. This begins to rise from 2012 through 2014 when the piezometric level improves to 3.8 mbgl. This fall and consequent rise in the groundwater levels corresponds well with the water content decrease and increase of the Ansupa Lake, respectively. When siltation in the lake has increased the groundwater has fallen and vice versa. In 2015-16 when the lake was silting up, filling up with weeds and algae and literally vanishing, the piezometric level saw the worst drop in the groundwater levels, i.e., 7.32 mbgl (Figure 10).
